**Daniel F. Ardito, PE**

**Review of Previous After-The-Fact Pictures**

*Daniel F. Ardito, PE* has completed this report of pictures of a previous After-The-Fact project I have looked at. This project was a wood frame deck attached to an older mobile home.

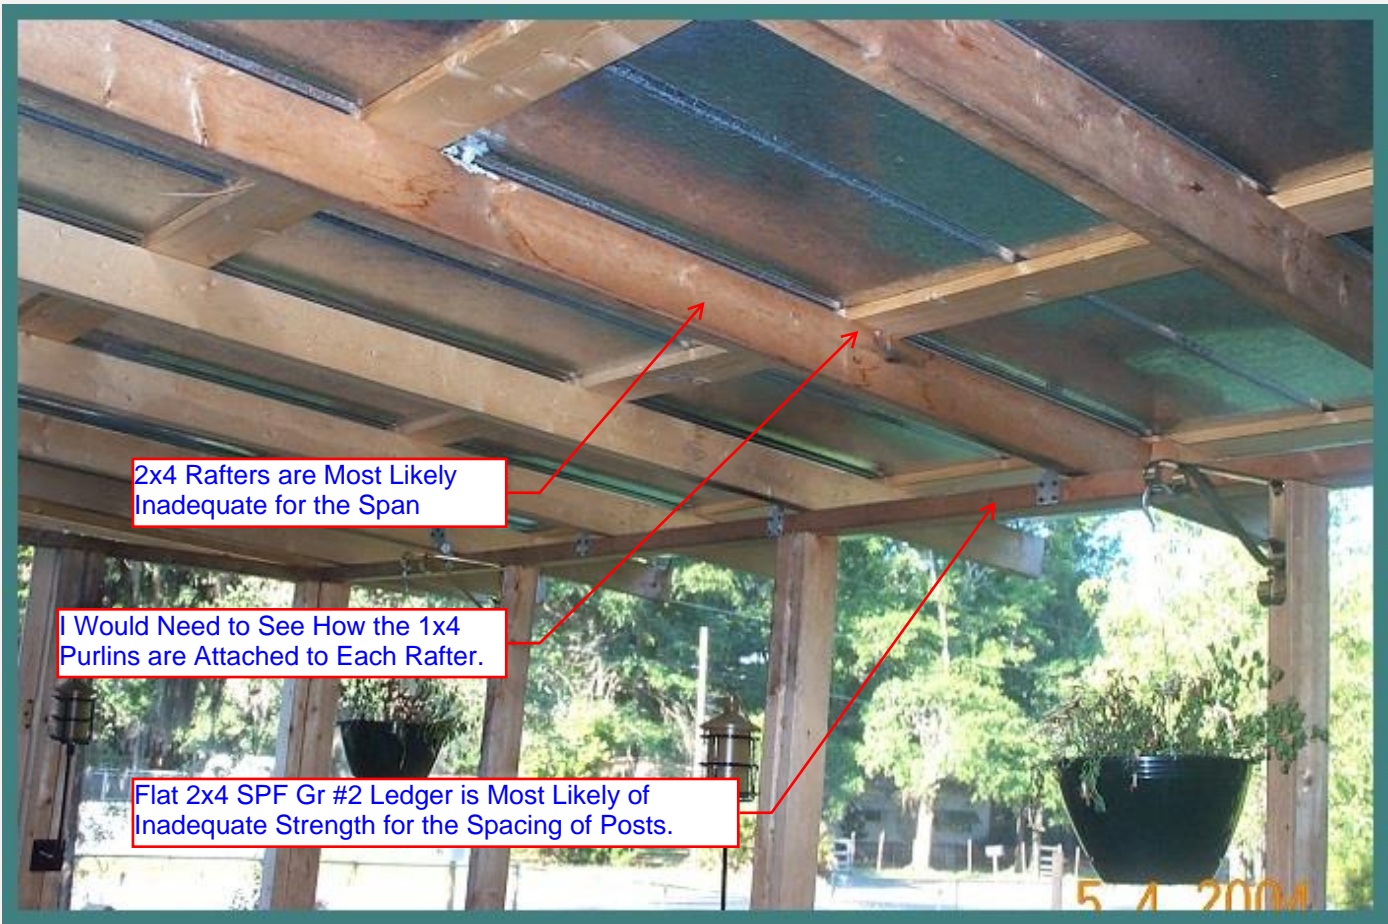
2x4 Rafters are Most Likely Inadequate for the Span

I Would Need to See How the 1x4 Purlins are Attached to Each Rafter.

Flat 2x4 SPF Gr #2 Ledger is Most Likely of Inadequate Strength for the Spacing of Posts.

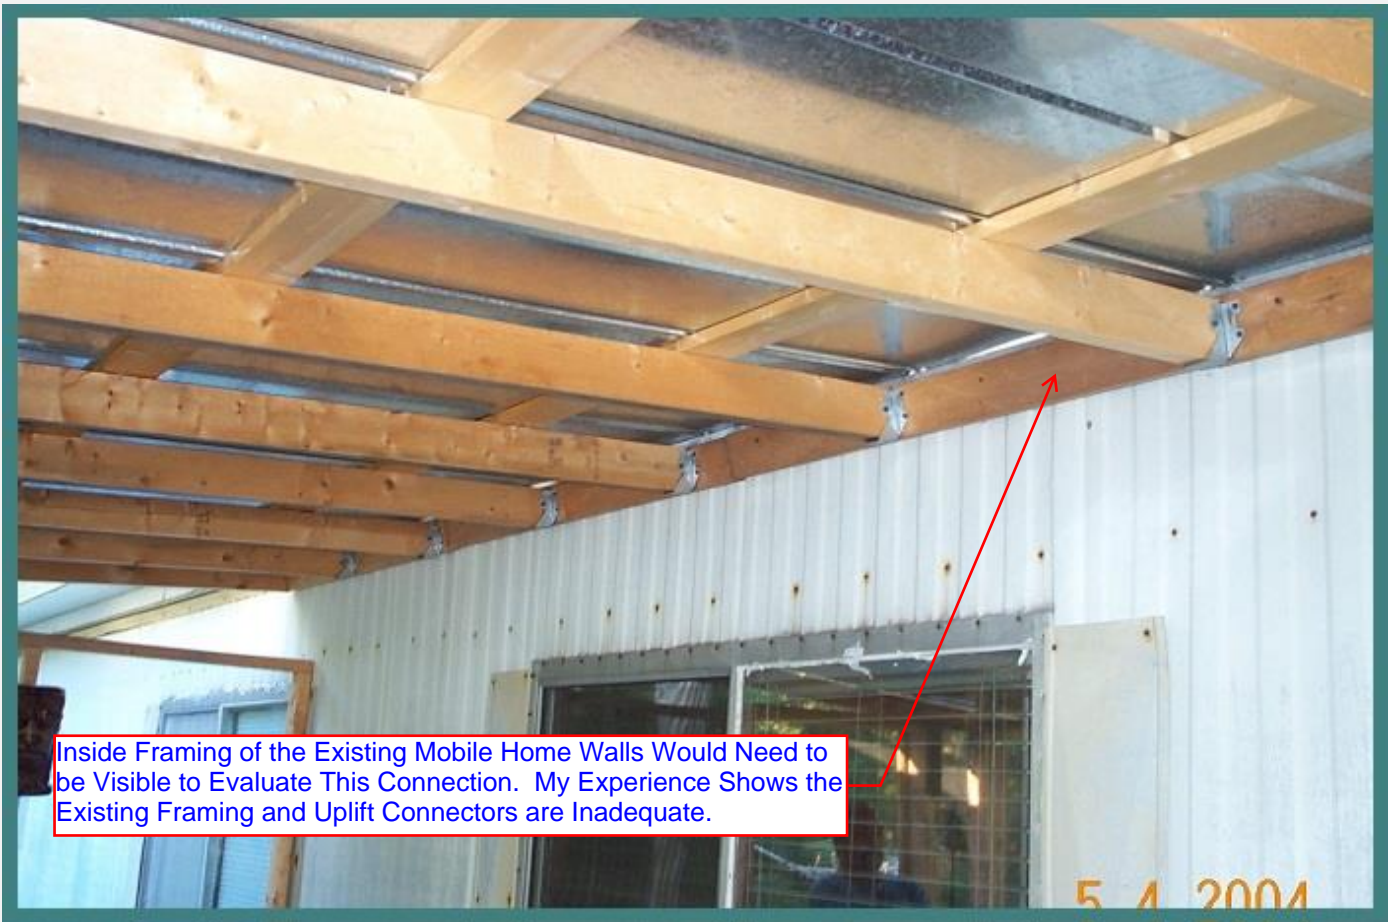
Inside Framing of the Existing Mobile Home Walls Would Need to be Visible to Evaluate This Connection. My Experience Shows the Existing Framing and Uplift Connectors are Inadequate.

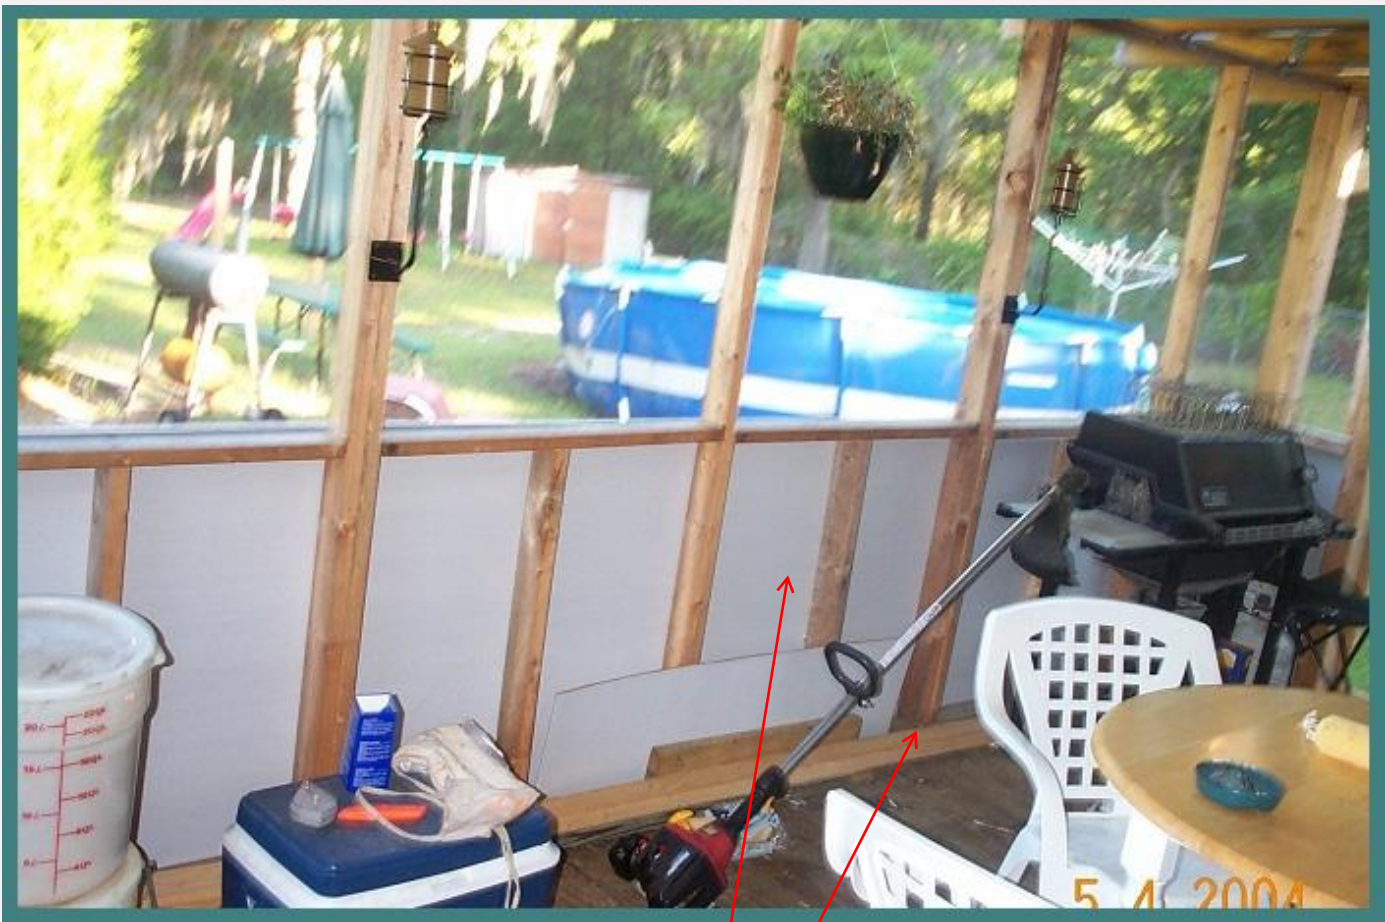
Standard Drywall Makes for a Poor Shear Wall and Will Not Last Long in Damp Weather.

Bottom of Posts Need to Be Connected to the Floor System With Some Sort of Uplift Connectors
