**Daniel F. Ardito, PE**

**Review of Previous After-The-Fact Pictures**

*Daniel F. Ardito, PE* has completed this report of pictures of a previous After-The-Fact project I have looked at. This project was a wood frame deck attached to an older mobile home.

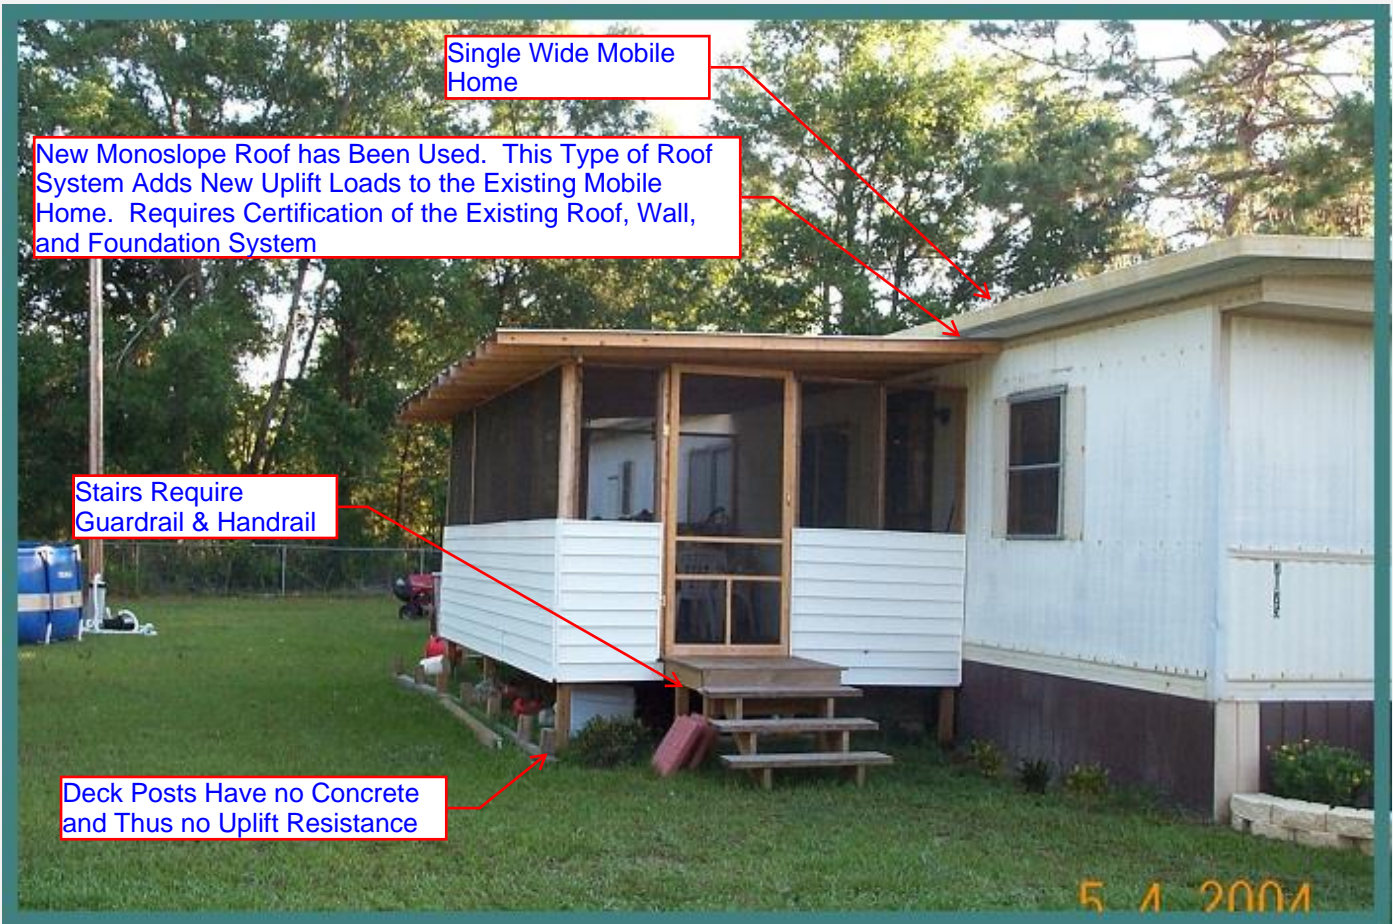
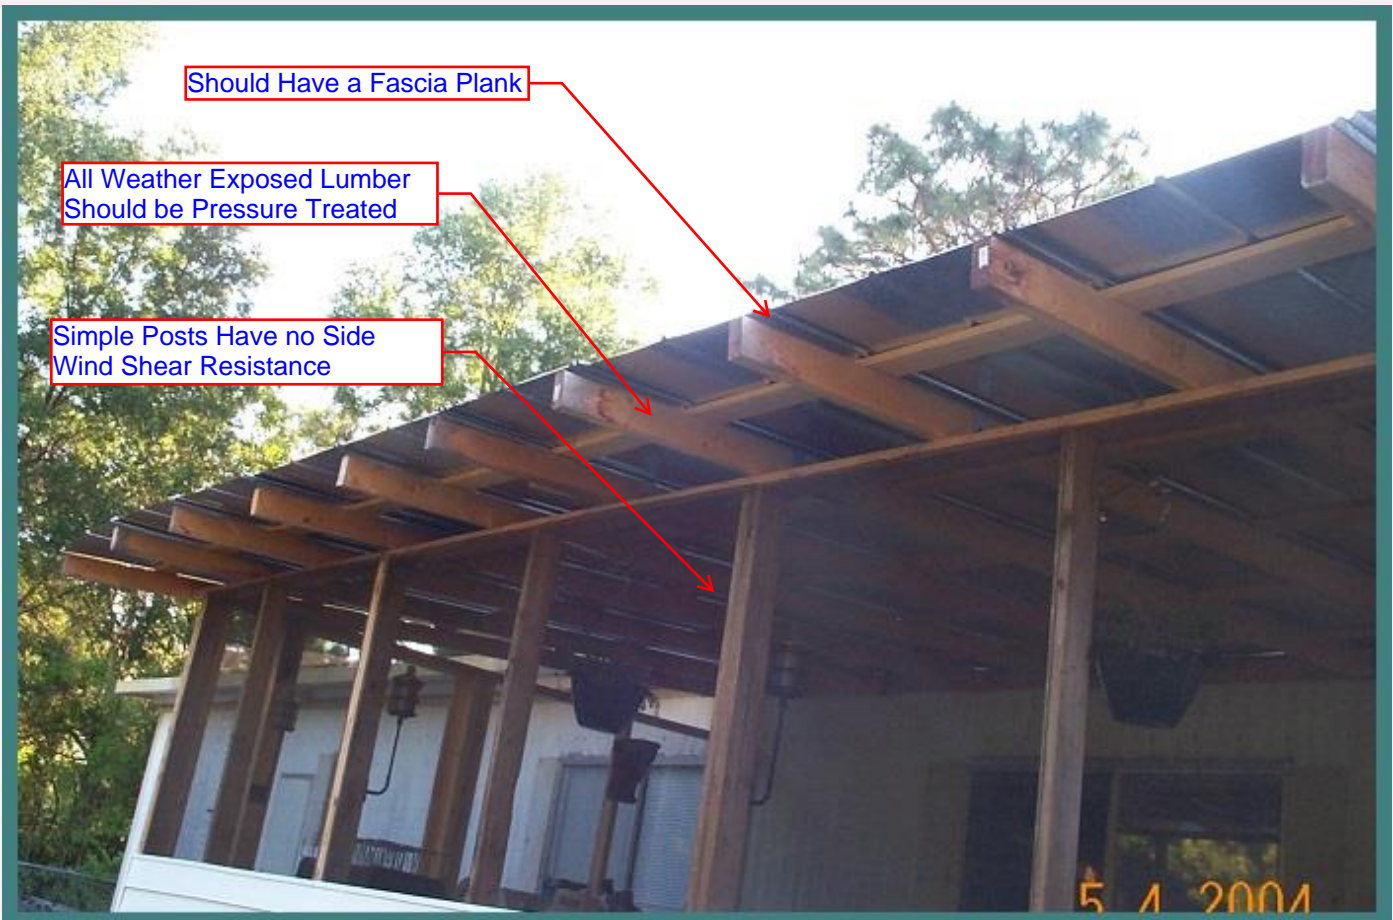
2x4 Rafters are Most Likely Inadequate for the Span

I Would Need to See How the 1x4 Purlins are Attached to Each Rafter.

Flat 2x4 SPF Gr #2 Ledger is Most Likely of Inadequate Strength for the Spacing of Posts.
